St. Margarets Railway Station

1870 to 1930

By
Stuart Moye

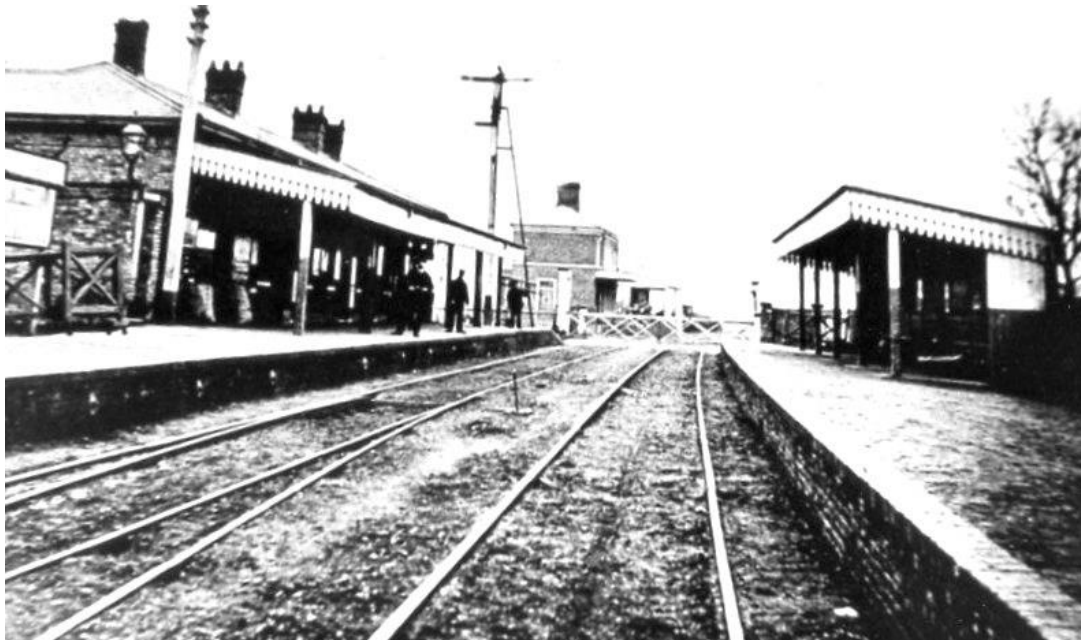
Early view of St Margarets Station

This view of St Margarets Railway Station looking south shows the gas lighting installed in 1878, which can be seen close to the corner of the building on the left. However the signal box built in 1887 has yet to appear thus enabling the picture to be dated within a nine year period. Also of interest are the early signalling [with a signal arm for both main line tracks on one tall post], the ash ballast covering the sleepers and simple throw over levers to operate the points at track level. The original station and goods shed can be seen in the distance on the far side of the level crossing. The Buntingford line ended in a bay platform with buffer stops behind the station name board to the very left of the picture.

This view illustrates the modernisation that had taken place at the station in the 20 odd years since the picture on page 1 above was taken. Although the signal box is the most obvious addition, the new signalling, telegraph poles and the overall quality of the track are all signs of the progress made in two decades. Also it shows more fully the positioning of platform gas lamps erected in 1878. In the foreground at track level can be seen a shunting signal operated from the signal box and planking between the rails, the latter covering the locking mechanism for the points, an important safety measure added in 1888. Connection of such equipment to the signal box was by thick wire or square section metal rodding activated by pulling the correctly numbered lever in the signal box. A long planked cover can be seen between the tracks leading from the shunting signal right back passed the level crossing and almost as far as the present bypass bridge over the railway. This covering enclosed the operating wires and rodding heading out from the signal box to various pieces of equipment along the railway. Installation of such covers occurred after a considerable number of shunting horses and their human companions were injured stumbling over the wires and rodding on the GER system. In 1896 an order was sent out that where there was considerable horse hauled traffic along a main line the boxing in of rodding and wires was to be carried out. At St Margarets in the C20th before WWI the level crossing gates were frequently closed against road traffic to allow heavy horses pulling a couple of wagons each to pass through. They were hauling sand and gravel as well as bricks from the Hailey Brick Company and the sand and gravel quarries located to the south of the station on what is now the 100 acre estate. Rail access to the brick works and quarries having been opened in June 1899 and a new siding to cope with the considerable extra traffic being laid in the railway yard to the north of the level crossing in May 1901. The new siding along with a roadway cost £1,367 11s 0d and also helped to deal with the growing general goods traffic which the small original goods yard south of the crossing was struggling to cope with. Along with the weighbridge added in 1892 this brought the goods facilities at St Margarets up to what would be its maximum development before the decline in goods traffic in the 1930s precluded any further investment. Looking back to the picture at the top of the page it is interesting to note how many enamel signs adorned the station, advertising such things as Pears Soap and Liptons Tea. This was a common feature of stations at the time and reflected the range of branded consumer goods that had become available in the later Victorian Period. The railway had played a major part in creating this change providing firms with the ability to sell their goods nationwide rather than the more locally produced often unpackaged non branded goods of earlier times. This led to the development of High Streets of shops which were to flourish in the first half of the C20th.

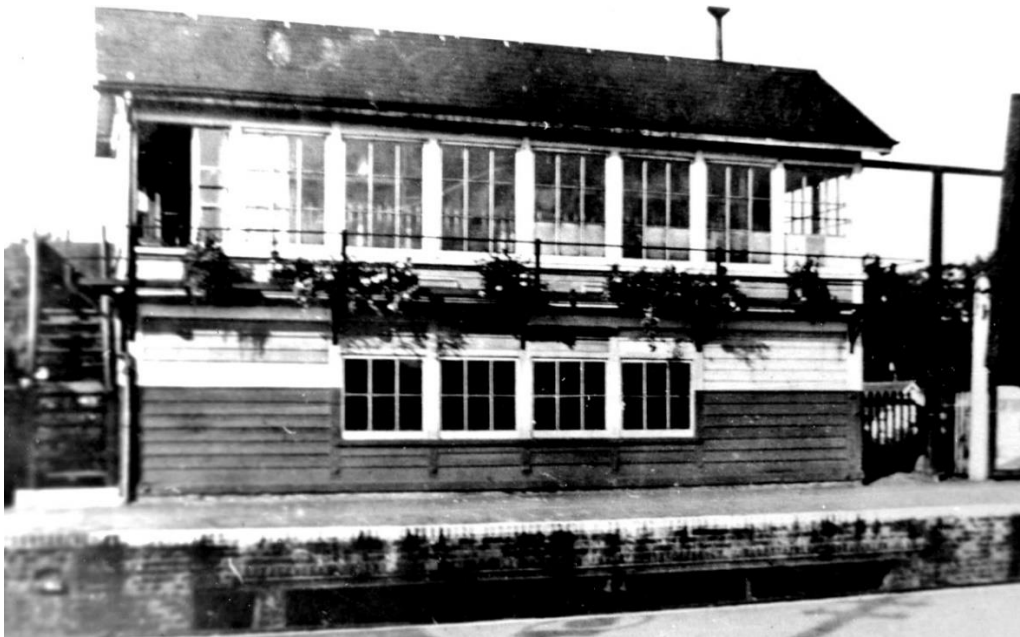
St Margarets Signal box

The big visible change for travellers at St Margarets station in late 1887 was the appearance of a large signal box next to the waiting shelter on the down [Hertford bound] platform. The picture shows the signal box as it appeared bedecked with flowers in the summer months of 1934. The building itself was erected during 1887 along with the fitting out of the box with all the equipment needed to comply with the new laws. The box as first built contained a 50 lever frame with just 6 left unused for future additions if needed. These were to operate the points and signals from one central place as required by the new law. Within the locking frame signals were interlocked with the positions of point blades so that signals could not show a proceed indication if the points were not set correctly. In the box were also located the block bell instruments which allowed the St Margarets signalman to communicate with the adjacent boxes at Ware and Rye house. This was done by using an agreed list of bell code signals tapped out using a piece of equipment not unlike a morse code sender key. Passengers soon became aware of the 3 pause 1 bell code as this indicated a passenger train would soon be arriving to take them on their journey. The use of the block instruments also prevented a train being sent to the next station along the line before the previous one had safely been seen to have arrived there. Complimentary changes outside the new signal box saw all the old signals removed and replaced with more modern semaphore signals, greater in number than before to more safely manage the movement of trains. The level crossing remained as it was, being opened and closed by a gateman from his small hut down by the level crossing on the village side of the line. Communication with the signalman being provided in the form of a plunger and bell at both locations allowing them to communicate using a prescribed code. It was not until 1897 that a lever in the signal box was brought into use that locked the level crossing gates in position against road traffic before the signals that allowed train to pass over the level crossing could be operated. This safety improvement was carried out as part of a new level crossing being needed when the road was widened. Although it is not known for how many hours a day the signal box was in use when first opened in 1887, it is known that in 1897 it was manned 24 hours a day every day of the year. It is an interesting thought that a person was on duty in St Margarets signal box, except for the odd strike and Christmas day closures in the latter part of the C20th, 24 hours a day every day between 1897 until the box was closed for good on the 27th May 2003.

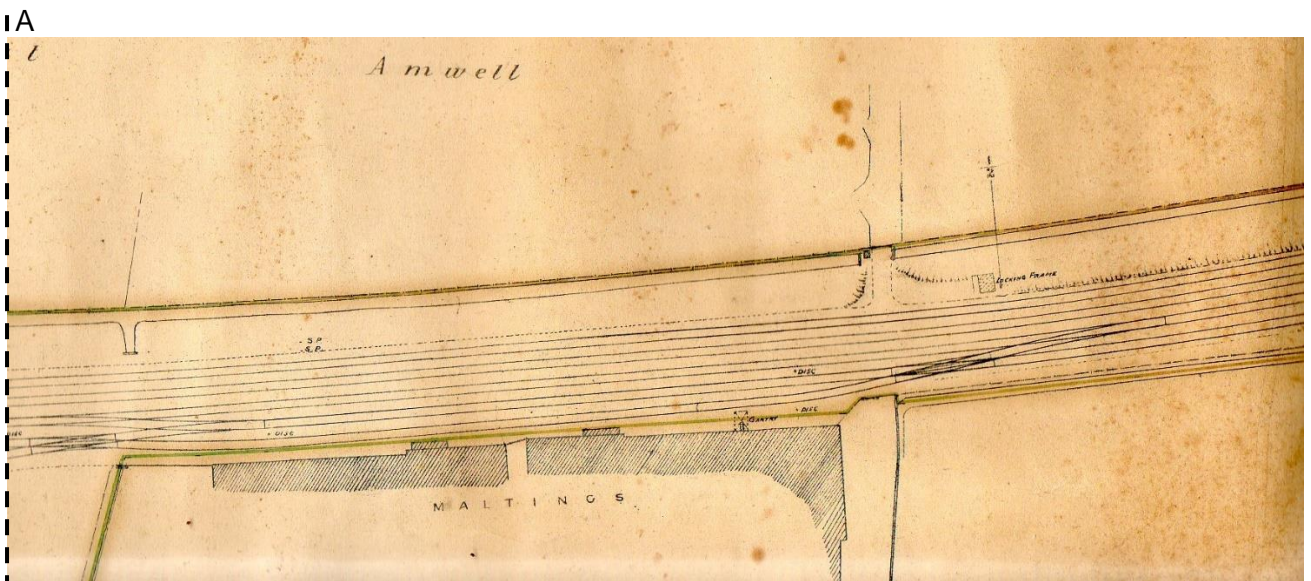
The above plan is included for completeness and shows the tracks that ran alongside Mr Hunt's Abbey Maltings. The Buntingford Branch being the centre one of five tracks alongside the malting. The level crossing still exists today and leads to Stanstead Lock and the Cruising Club.

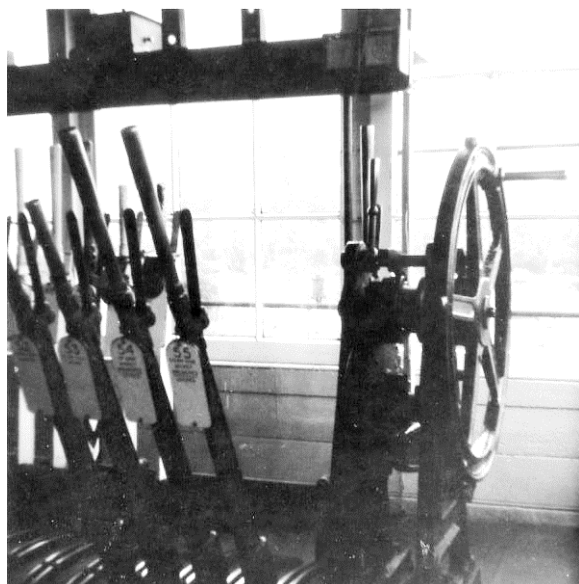
The Gate Wheel in St. Margarets Signal Box

This picture of the gate wheel in St. Margarets Signal box was taken in August 1970 the last summer it was in use. The remains of one of the cut off ships wheel type handles can be seen on the top of the wheel as well as the shiny steel replacement on the side. The position of the levers in this view suggest that the gates are closed against the road and the signals for a train from Rye House have been pulled off as the train runs along the track between Rye House in the St Margarets direction. The bulk of the wheel mechanism is hidden out of site beneath the floor. It was so arranged to turn the circular motion of the wheel into a push or pull of the rods that stretched all the way to the level crossing.

Not surprisingly the 1914 to 1918 War saw little investment at a small station like St. Margarets. It was not until 1921 that changes to the level crossing and how it was operated was authorised. The change involved moving the control of the level crossing gates away from the gateman manually operating the gates from his small hut next to the crossing to the signaller in the signal box. This of course would reduce the number of staff and in that way was seen as a worthwhile investment. However the practicalities of doing this presented a few problems. The lever frame in the box had to be extended at the level crossing end to provide extra levers to control the main gates and wicket gates. This addition increased the frame from 50 to 56 levers [with just 4 spare] but left little space for the installation of a wheel to wind the main gates. The signal box at St Margarets was about as far away from the level crossing as one really wanted to be for using hand wound gates. The most capable type of winding mechanism available was a long horizontal threaded rod some 4-5 feet long turned by a large wheel at one end. This being all supported on a substantial cast iron frame giving the signaller a well geared down wheel making it easier to open and close the four gates. Unfortunately, there was insufficient space in the signal box, [*once the lever frame was lengthened at the crossing end of the box*], for this type to be used. A solution was found in modifying a redundant smaller gate wheel mechanism said to have come from an East London signal box. This had been used in a box close to its level crossing and was of the ships wheel pattern with handles around the rim. It also had a less geared down mechanism ideal for much lighter jobs than the rather heavy job it had been chosen for at St Margarets. However, it would fit the limited space available, so modifications were made so that it could do the job, but presented a heavy wind for the signaller. The most obvious modification involved the removal of the ships wheel handles around the rim and replaced by a side handle which would give enough purchase for the signaller to wind four heavy gates. The square section rodding and cranks which joined the wheel to the gates would bend and strain against their guides and pivots, making winding the gates even more difficult.

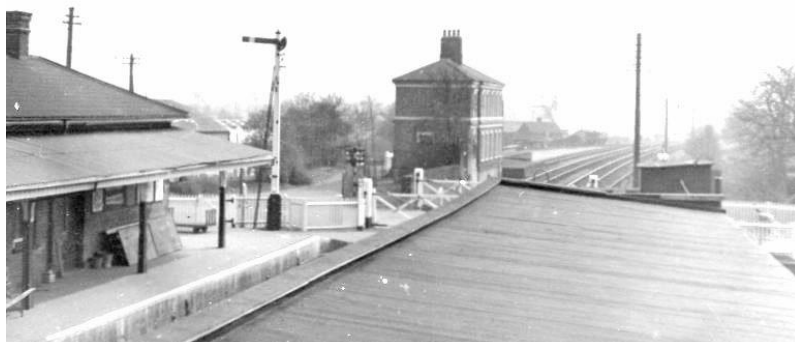
The Level Crossing viewed from the Signal Box

An additional problem at St Margarets was how little of the level crossing could be seen from the signal box the view being blocked by the roof of the down side waiting shelter. This was to some extent mitigated by providing two mirrors, one located opposite the box and the other on the far side of the crossing. However, there was still at least 25% of the crossing that the signalmen could not see clearly which was to lead to at least one serious incident where lives were put at risk. This 1950s picture also shows the semaphore type signals in use from 1887/8 with later improved versions until 1959. The picture shows the view the signalman had when winding the gates. The actual winding was a difficult skill to master and required a real effort to get the gates moving and then immediately required back pressure on the wheel to slow the gates down. If the gates were wound too fast at the end of the gates swing, they would jump out of the gate locks set into the crossing surface. A real danger for signalmen was if a vehicle tried to jump the gates as the impact with the gates made the wheel suddenly jerk backwards with considerable force. At least two incidents of signalmen being thrown out of the open signal box window occurred with one landing seriously injured on the platform the other bruised and upside down on the narrow balcony outside the box window.

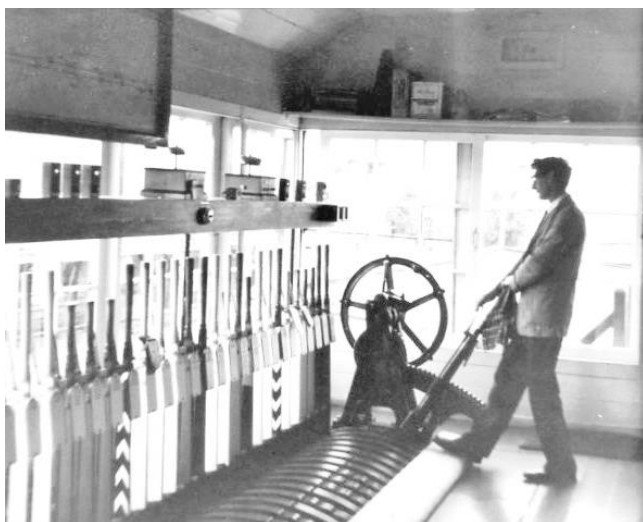
This view of the signal box interior was taken in August 1970 in the last few months of the wheel being in use. It was removed in October 1970 and replaced by a box with push buttons to operate the newly installed lift up barriers at the level crossing. The signalman Mr Sam Vincent is seen about to operate number 56 lever as he starts the sequence of closing the gates against the road traffic for the imminent arrival of a train. Part of the lever frame and other signalling instruments are also visible in the picture.

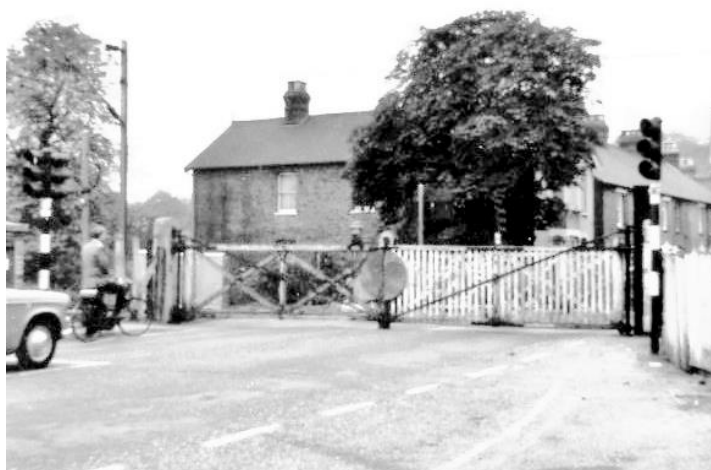
A view of the level crossing also taken in August 1970. The gates are somewhat battered and mended due to recent damage caused when a vehicle tried to jump the gates. This crossing was one of the first in the country where road traffic was controlled by traffic lights, brought into use in the late 1930s. The police would visit this spot regularly due to the high frequency of drivers trying to squeeze through the gates as they closed to avoid being delayed.

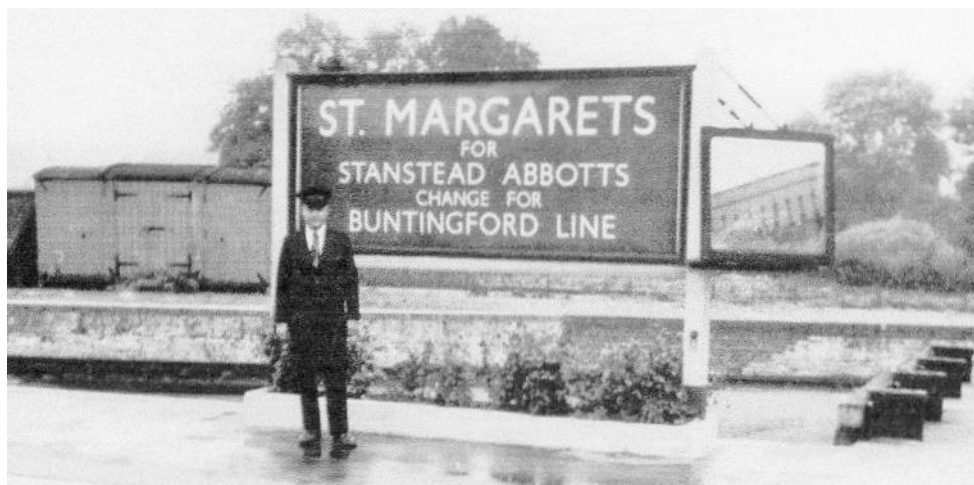
A Stationmaster stands proudly in front of the running in board erected near the buffers stops of the Buntingford branch. The two part enamel sign was very impressive not just for its size but also its distinctive white lettering on dark blue background. Hung on the right of the board can be seen a mirror, provided to afford the signalman a view of part of the level crossing blocked from his direct view from the signal box.

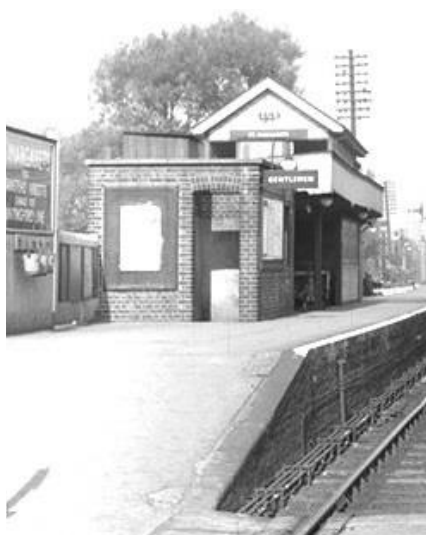
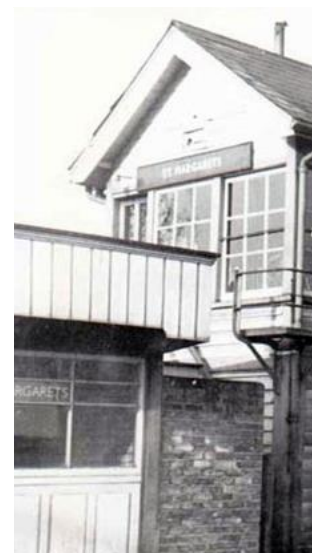
These two pictures show the additional facilities added to each end of the covered shelter by 1927. The signalman's toilet being hidden behind the low wall between the shelter and the signal box. Part of the screen and one of the two glass St Margarets signs in the screen can be seen in the right hand picture. The left hand picture shows the gent's toilets with the ladies room behind accessed from under the canopy

In 1926/7 it was decided to improve the limited facilities on the downside platform for those waiting to travel to Ware or Hertford. The open sided shelter had for some 80 years been the only cover provided for passengers on the down platform. A gent's toilet and a ladies room with toilet were added to the level crossing end of the canopy. At the other end a brick wall was built across the end and a toilet for use by the signal man was built between the new wall and the signal box steps. The open fronted shelter was fitted with a wooden screen with windows in the upper part. This blocked in the half of the open front at the signal box end. Within the glazing were two unusual station name signs made of two layers of glass. The wording simply stated St. Margarets in the then new LNER house style of white lettering on dark blue background. These improvements provided considerably more shelter from the wind and driving rain than had previously been the case.

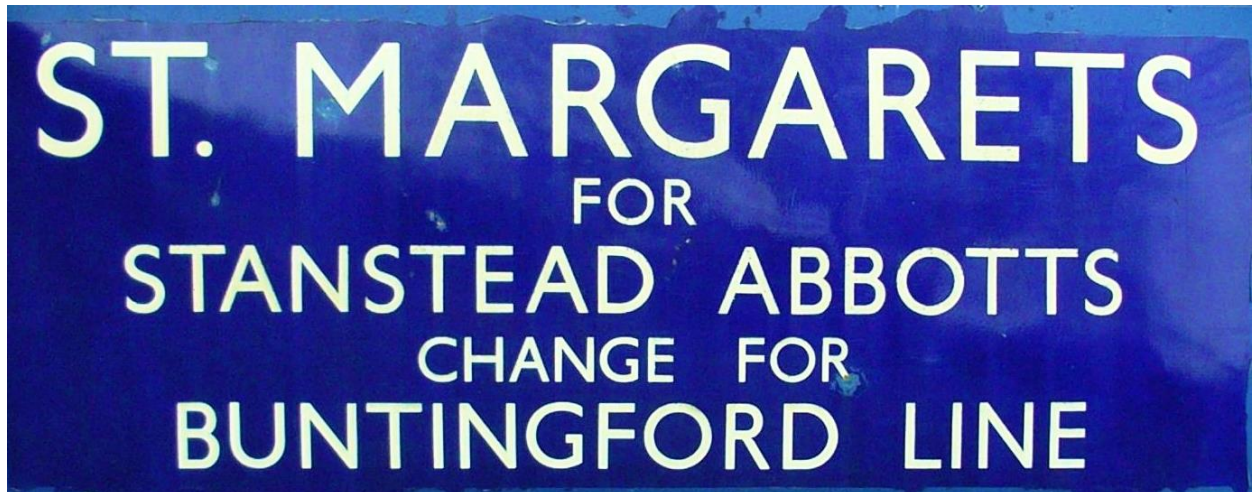
LNER style running in board at St Margarets Station

The LNER provided St Margarets with four large enamel signs which attempted to make clear that St Margarets was the station for Stanstead Abbots. The confusion with Stansted on the mainline north of Bishops Cleeve caused quite a few passengers over the years to catch the wrong train. During the times that the majority of visitors to the village came by train village public houses, notably the Red Lion, would emphasise in their advertising that St Margarets was the station for Stanstead Abbots. The lower part of the sign would remind passengers as the train was running into the station that they should change at St Margarets for the Buntingford Branch. After the Buntingford line closed to passengers in November 1964 the bottom part of the signs were crudely obscured with grey paint.
